# Drainage Report

Site  
**Mr Jones**  
**24 Albemarle Terrace**  
**Taunton**  
**Somerset**  
**XX0 0XX**

## Albemarle Terrace - CCTV Survey Report : 31/08/18

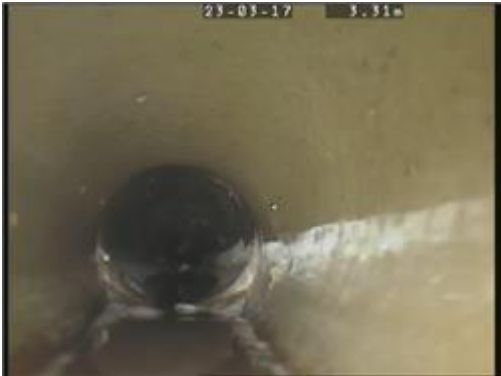
Pos	Video Ref	Code	Cont.	Description	Image
00.00m		MH		Start node type, manhole MH C1	
00.00m		WL		Water level: 0% Height/Diameter	
03.30m	0:00:22	WL		Water level: 15% Height/Diameter	Image Provided - Ref: 0_2

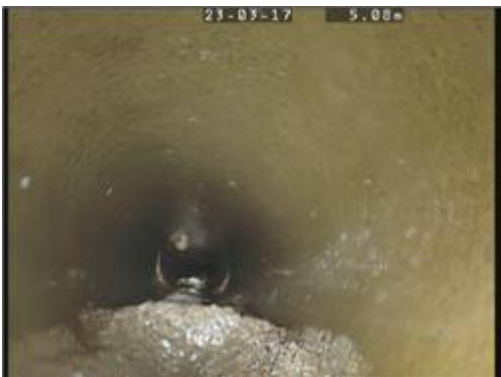
<p><b>Section: 1</b></p> <p>From: MH C1 To: MH C2</p>	<p>There is evidence of poor fall and some root infiltration. Our recommendation would be to remove the root infiltration and patch line this area to prevent further growth. The drain would also benefit from cleansing to remove silt.</p>	<p><b>DRB Grade: B</b> <b>Pipe Size: 100</b> <b>Material: Vitrified Clay (i.e. all clayware)</b> <b>Use: Combined</b></p>
<p><b>Section: 2</b></p> <p>From: MH C2 To: MH C3</p>	<p>There is evidence of root infiltration at a number of joints and a Large Open Joint at 6.6 metres. Cutting the roots out and lining the drain would prevent further root infiltration and make the drain watertight.</p>	<p><b>DRB Grade: C</b> <b>Pipe Size: 100</b> <b>Material: Vitrified Clay (i.e. all clayware)</b> <b>Use: Combined</b></p>
<p><b>Section: 3</b></p> <p>From: MH C3 To: Interceptor</p>	<p>Grade A</p>	<p><b>DRB Grade: A</b> <b>Pipe Size: 100</b> <b>Material: Vitrified Clay (i.e. all clayware)</b> <b>Use: Combined</b></p>

05.10m	0:00:34	DES		Settled deposits fine: 20% Cross sectional area loss - Severity 3	Image Provided - Ref: 0_3

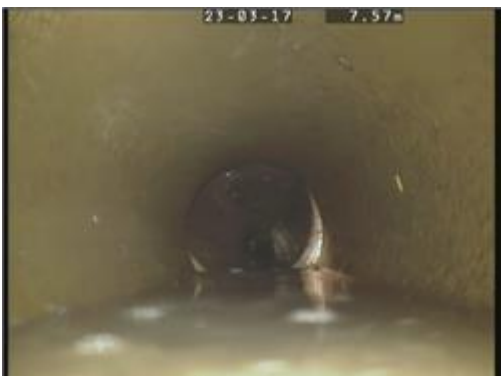
07.57m	0:00:50	WL		Water level: 20% Height/Diameter	Image Provided - Ref: 0_4

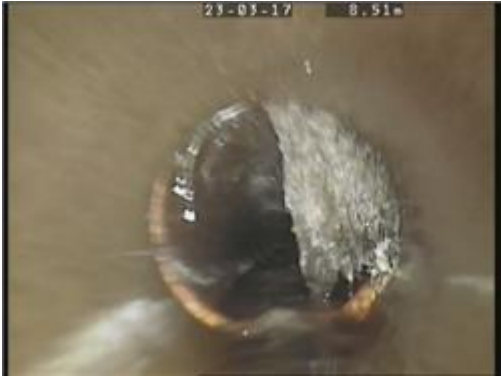
Pos	Video Ref	Code	Cont.	Description	Image
08.50m	0:01:16	RJ		Roots at joint - Severity 3	Image Provided - Ref: 0_5

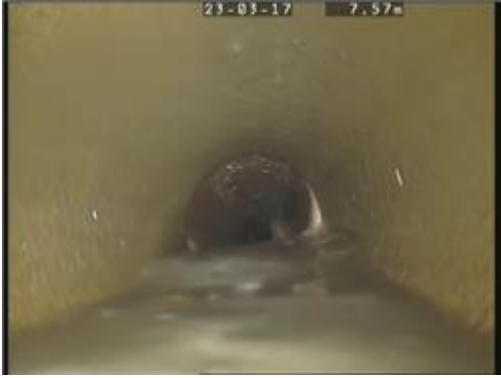
08.50m	0:01:32	LRH		Line of drain/sewer deviates right [half]	Image Provided - Ref: 0_6

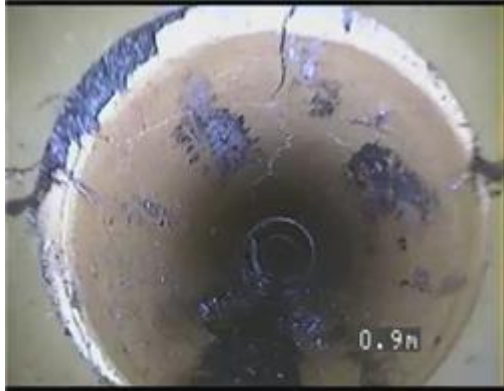
Pos	Video Ref	Code	Cont.	Description	Image
00.00m		MH		Start node type, manhole MH C2	
00.00m		WL		Water level: 0% Height/Diameter	
00.90m	0:00:10	RJ		Roots at joint - Severity 3	Image Provided - Ref: 1_2

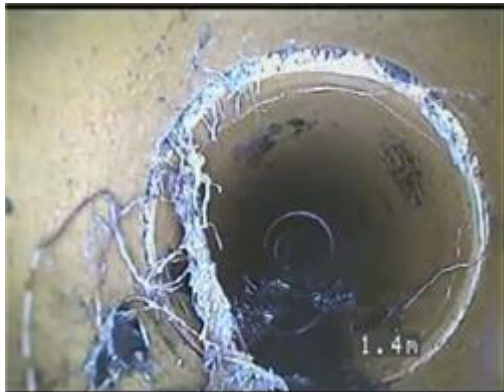
00.90m	0:00:10	FLJ		Fracture longitudinal at 12 o'clock at joint - Severity 3	
00.90m	0:00:10	FCJ		Fracture circumferential from 10 o'clock to 03 o'clock at joint - Severity 3	
01.50m	0:00:17	RJ		Roots at joint - Severity 3	Image Provided - Ref: 1_5

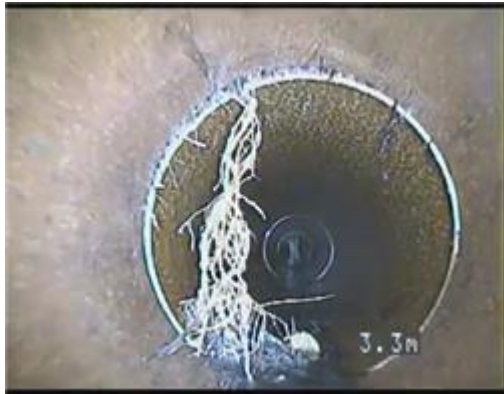
Pos	Video Ref	Code	Cont.	Description	Image
03.30m	0:00:32	RJ		Roots at joint - Severity 3	Image Provided - Ref: 1_7

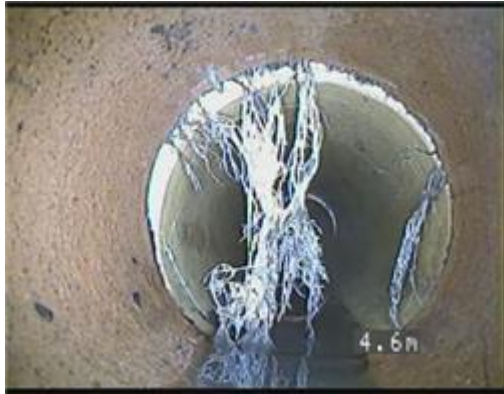
04.60m	0:00:44	RJ		Roots at joint - Severity 3	Image Provided - Ref: 1_8

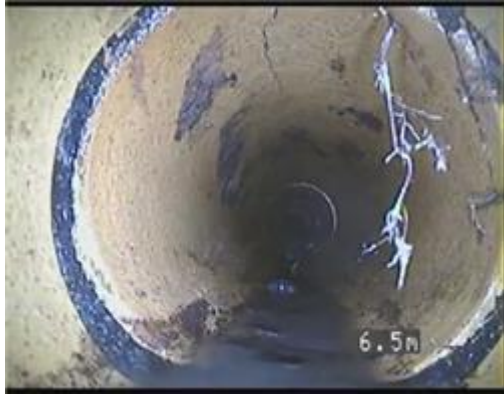
06.50m	0:01:03	OJL		Open joint large - Severity 4	Image Provided - Ref: 1_9

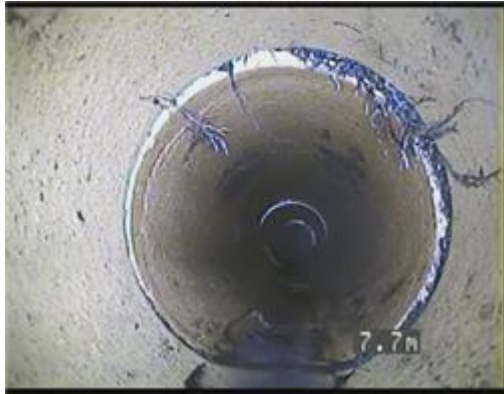
Pos	Video Ref	Code	Cont.	Description	Image
07.70m	0:01:12	RJ		Roots at joint - Severity 3	Image Provided - Ref: 1_12

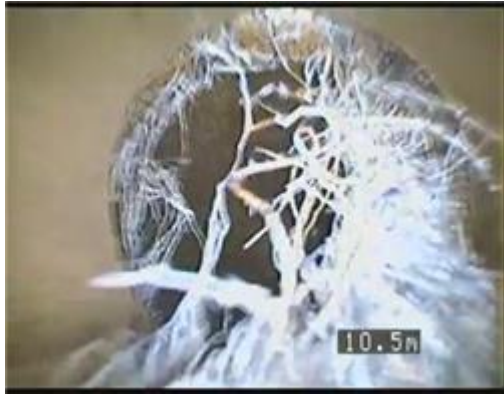
10.40m	0:01:38	RJ		Roots at joint - Severity 3 Mass Roots 60%	Image Provided - Ref: 1_13

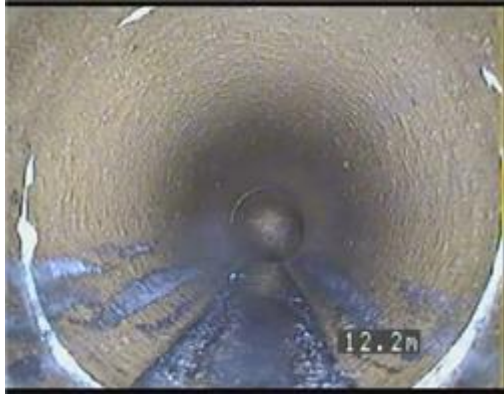
12.20m	0:01:56	FCJ		Fracture circumferential from 03 o'clock to 09 o'clock at joint - Severity 3	Image Provided - Ref: 1_14

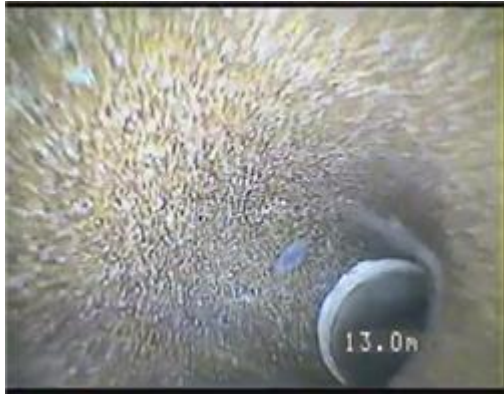
Pos	Video Ref	Code	Cont.	Description	Image
13.00m	0:02:08	LRH		Line of drain/sewer deviates right [half]	Image Provided - Ref: 1_15
